ASSOCIATED INSPECTION SERVICES

Inspection Report

SAMPLE REPORT

1234 Mainstreet, Your Town

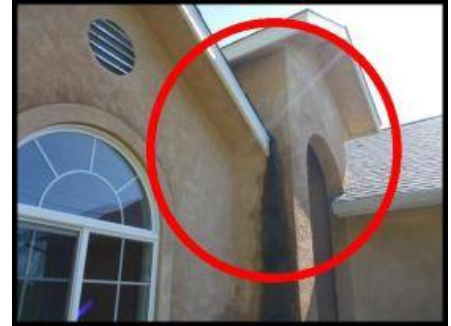
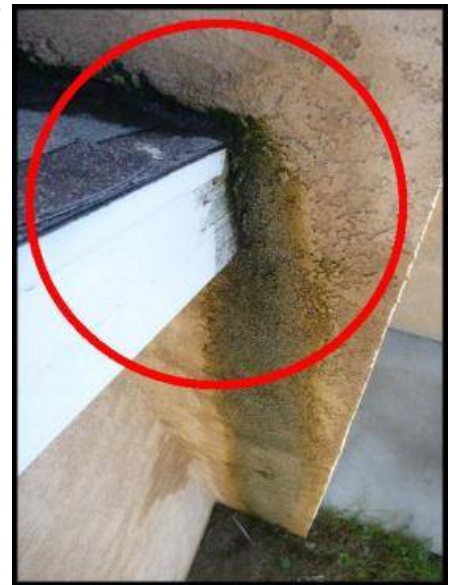
2.2 STUCCO CONDITION: Water intrusion is one of the most serious conditions home inspectors will find. I attempt to find and describe the cause of the condition and the extent of damage. The use of circles and photos help my clients identify the issue.

In this case, the issue is lack of proper kick out flashing and roof to wall flashing.

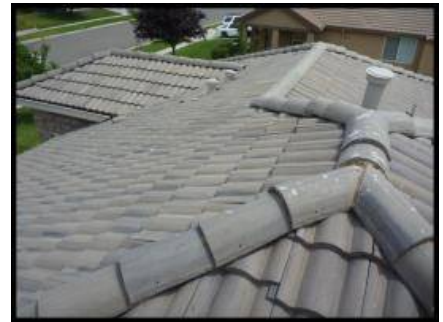
3.1 CONDITION: **Few systems of your new home are more important than the condition of the roof. I have installed most types of roofing material over my 30+ years in construction. With this experience, I am able to identify current conditions and produce an accurate assessment.**

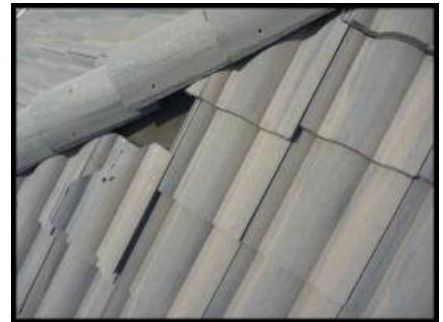
3.2 METHOD USED TO INSPECT: The following was observed upon walking on the roof. **Many inspectors refuse to walk on a roof. I walk on all roofs that are safe to walk on. I have been trained by Monier/Lifetile on installing and walking on tile roofs.**

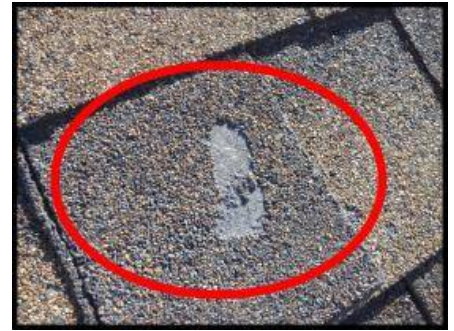
Architectural composition shingles. Note: With regular maintenance average life expectancy is between 20 -25 years under normal installation/conditions. **Damage to roof materials is much easier to see when the inspector is on the roof.**

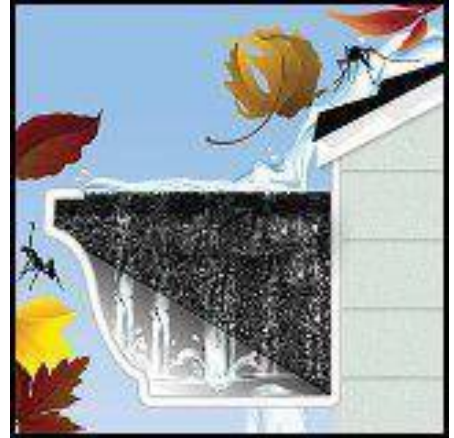
3.4 RAIN GUTTERS There is a foam filler material available that looks promising as a solution to leaves in the gutter. I have seen this product available at Costco and online. **When possible, I try to include information that may be helpful for new homeowner.**

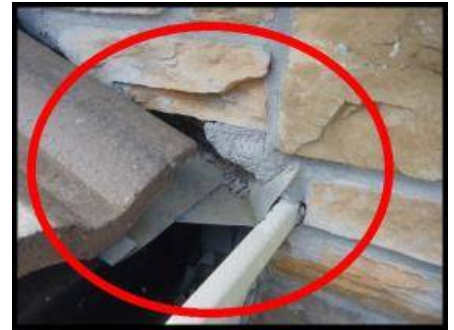
3.5 KICK-OUT FLASHINGS: Installed and serviceable.

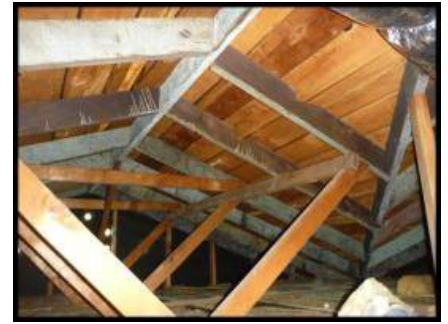
2 x 6 rafters spaced at 24 inch centers. Installation has been made in a less than professional manner. Opposing rafters do not meet together at the ridge as required. Although this installation may not meet standard construction practices, the installation has been in place for many years with no noticeable deficiencies.

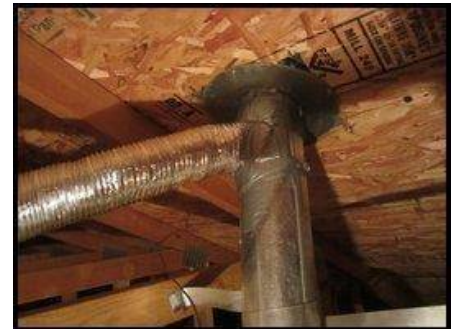
Improper use of aluminum flex for exhaust venting. This material is not rated for this use and is a possible fire hazard.

This is a health and safety issue and requires your attention. I will use red text to get your attention on serious safety issues. This condition is an example of an issue in an area that any homeowners will not access and if they did, may not understand what they are looking at.

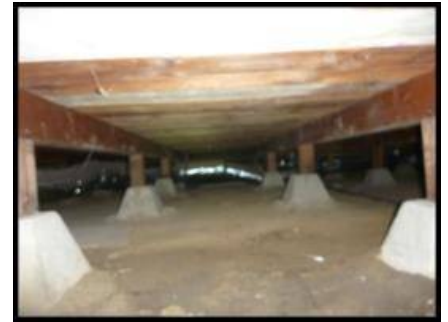
- 8.1 METHOD OF INSPECTION: **A visual inspection of the crawl space can reveal many conditions. Leaking plumbing and ductwork are not uncommon and are best view by crawling into the substructure. I have the experience to quickly evaluate these, in addition to structural systems and electrical issues.**
- 8.2 STRUCTURE: **I include photos of conditions in areas most clients may never enter.**

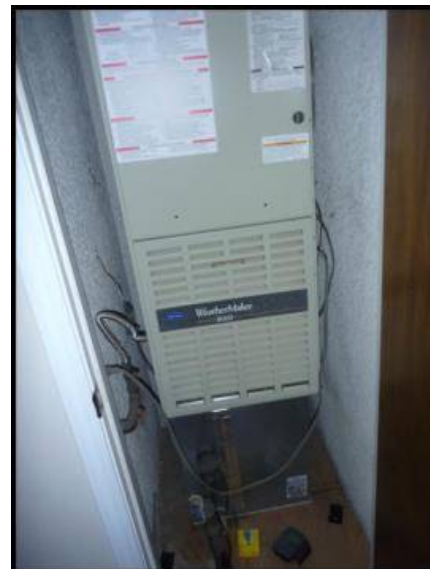
10.1 CONDITION: **There are many types of heaters and I have taken numerous classes to familiarize myself with the health and safety issues of many of these systems.**

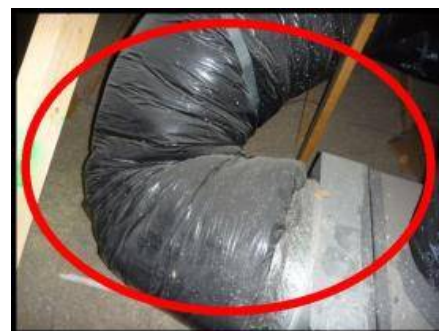
10.2 DUCTWORK: There are tight bends in the duct work that might reduce flow. Manufacture recommends....Radius at center line shall not be less than one duct diameter. Further evaluation by an HVAC contractor is recommended. **This was a 3 year old home, the seller reported the home was difficult to cool. Repairs were made and flow was restored and unit performs well. Cost very little to repair and will save a lot of money and my client will live more comfortably.**

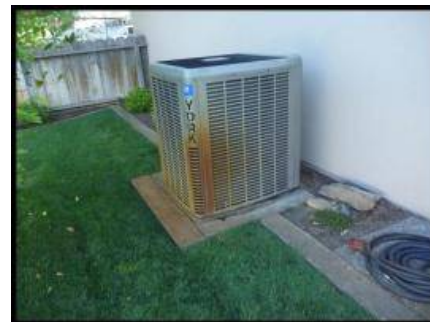
10.4 CONDITION: **Air conditioning is very important in this climate. I evaluate all installed units by running the unit, testing the output and reporting on the visual conditions.**

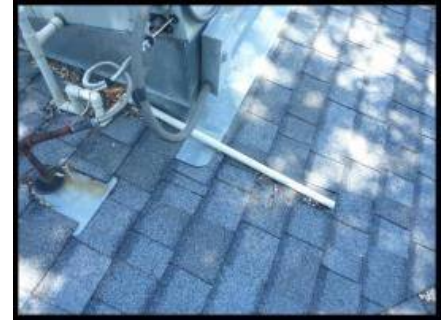
10.5 EVAPORATOR DRAIN LINE: I recommend the condensate drain is extended to drain directly into the downspout so moisture is not added to the gutter system during the cooling season. This may prevent rusting of the gutter. **I try to include information about components and installations that may help my clients improve or extend the life of their investment.**

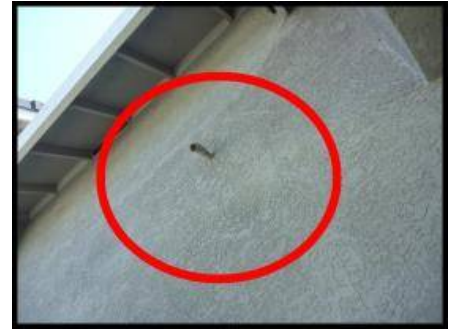
10.6 SECONDARY DRAIN LINE: The secondary drain line terminates above the window shown in the photo. It is placed above this window so if there is a time when water drains from this pipe it will be noticed by the occupants. This indicates the primary drain is plugged and needs the attention of a service technician to prevent damage. This is sometimes referred to as a tattle tale drain. **This is an informational item only and not a negative condition. There may be components that my clients are not familiar with so I try to inform them as part of the service.**

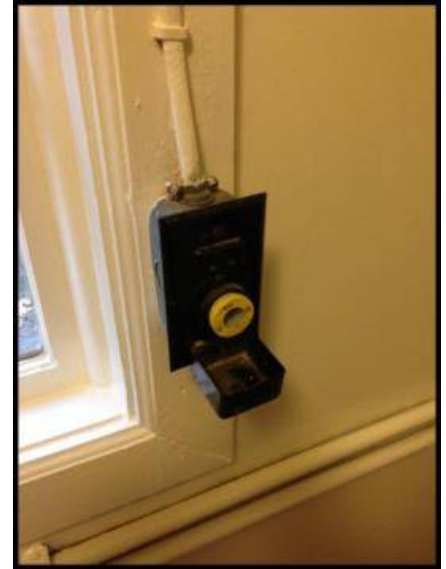
This is an older style outlet that has its own built in twist type fuse for overload protection. The outlet is very serviceable. This is an observation for your information and not considered a negative condition.

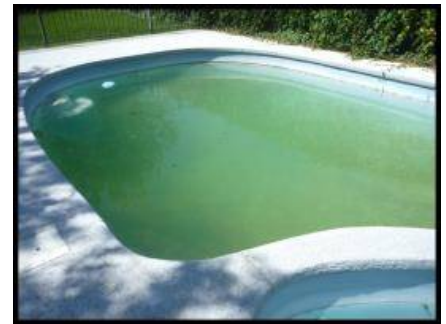
I do pool inspections. There can be many health and safety issues and have them identified can be very helpful.

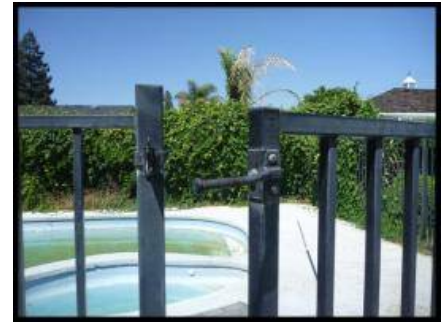
12.2 POOL FENCE: **Fencing and gates are important for safety and most insurance companies have specific requirements. I look and report on many of these issues.**
